# NATURAL SCIENCES REPORT

## HIGHWAY 7 CORRIDOR AND VAUGHAN NORTH-SOUTH LINK PUBLIC TRANSIT IMPROVEMENTS INDIVIDUAL ENVIRONMENTAL ASSESSMENT

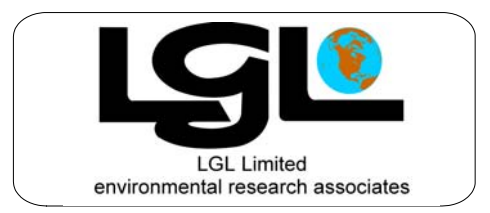
Project:	TA2818	Figure:	2
Date:	September 2003	Prepared By:	MWF
Scale:	1 : 70,000	Checked By:	GNK
